Landslide Remediation on Ohio State Route 83 Using Clean Coal Combustion By-Products

Renee Payette, *District 5, Ohio Department of Transportation, Jacksontown, Ohio*; Xi You Chen, *William Wolfe, The Ohio State University, OH*; Joel Beeghly, *Dravo Lime Co., PA*

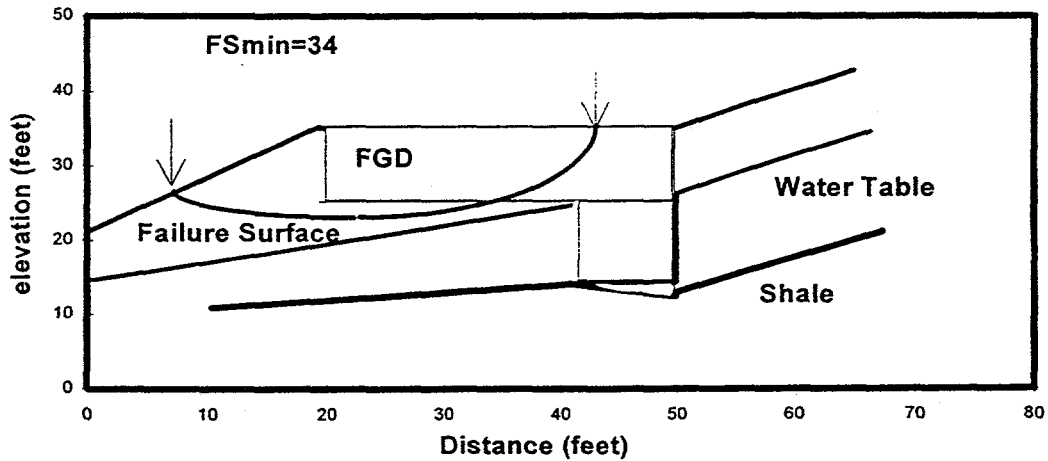
Figure 4 Failure surface in FGD

results of the stability computations for the FGD only section. As in the case of the FGD-soil mixture, the critical failure surface passes through the FGD. Also, as was found with the mixture, the minimum Factor of Safety is very high, in this case in excess of 33. It is clear that the use of FGD or FGD modified soil can significantly improve the safety and stability of hillside construction of the type found on Ohio SR 83.
